THE UNITED STATES
STRATEGIC BOMBING SURVEY

THE EFFECTS
OF
THE ATOMIC BOMB
ON
HIROSHIMA, JAPAN

Volume III

Physical Damage Division

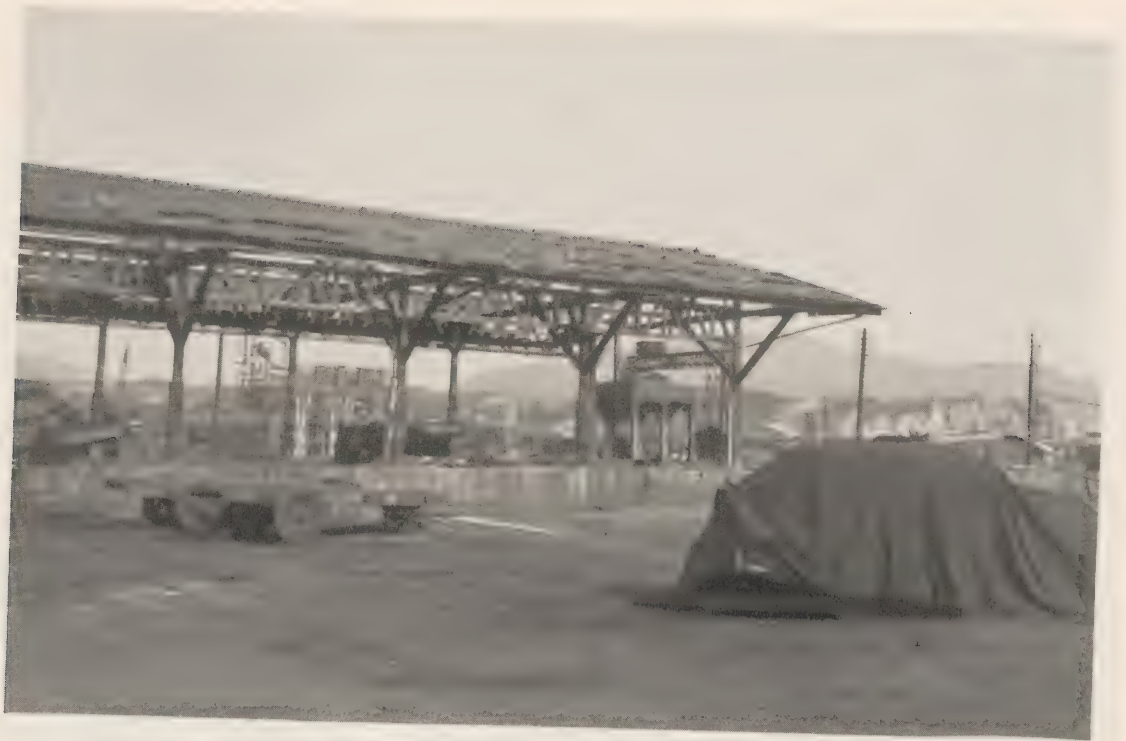
PHOTO 36-XIII. Roof stripped from transit sheds by blast, 8,500 feet from GZ.

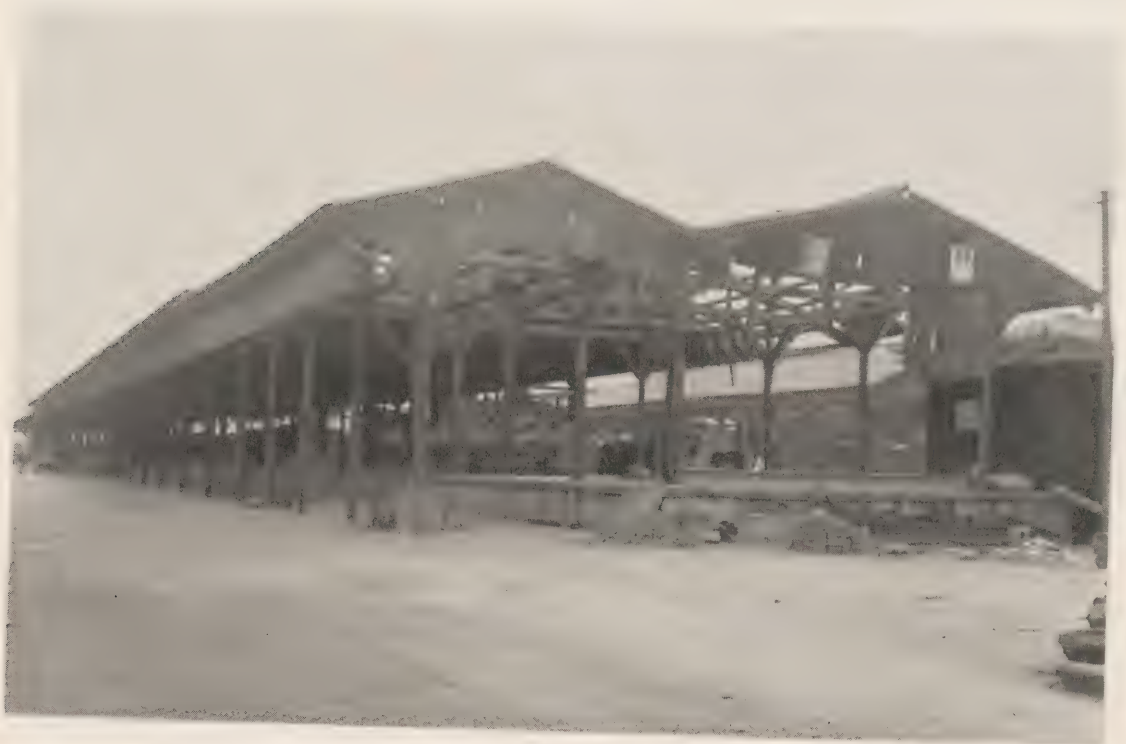
PHOTO 37-XIII. Transit sheds damaged by blast, 8,700 feet from GZ.

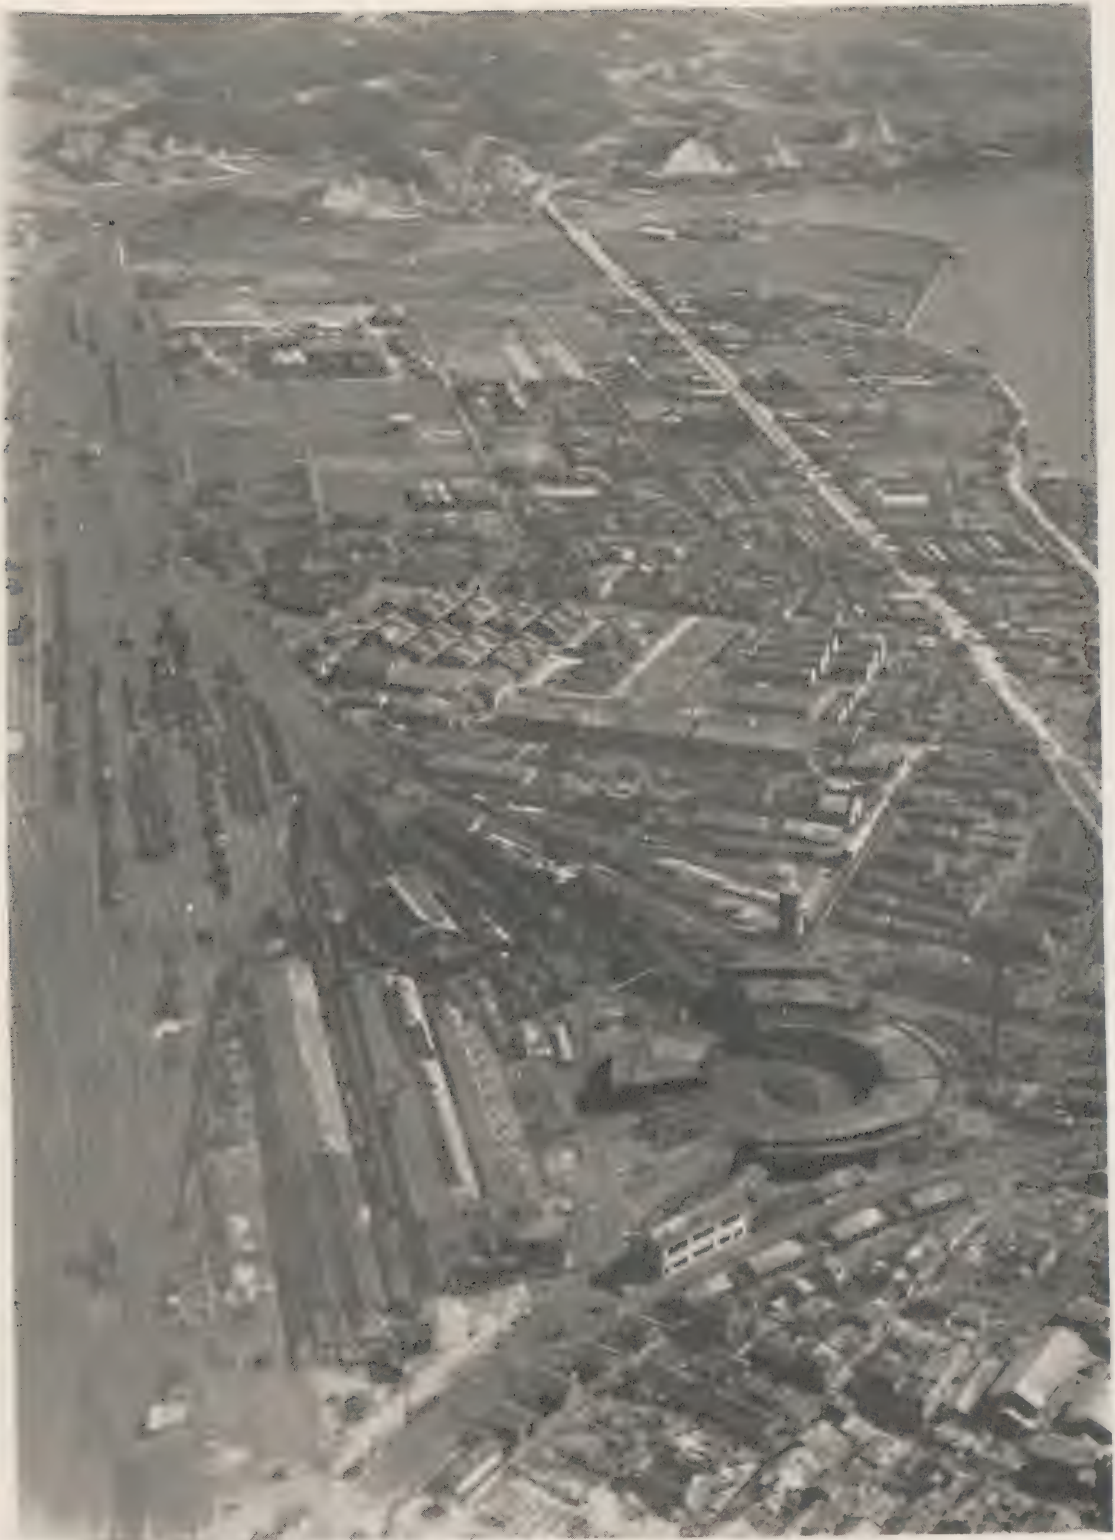
PHOTO 42-XIII. Classification and repair area, 8,500 feet from GZ, showing general damage.

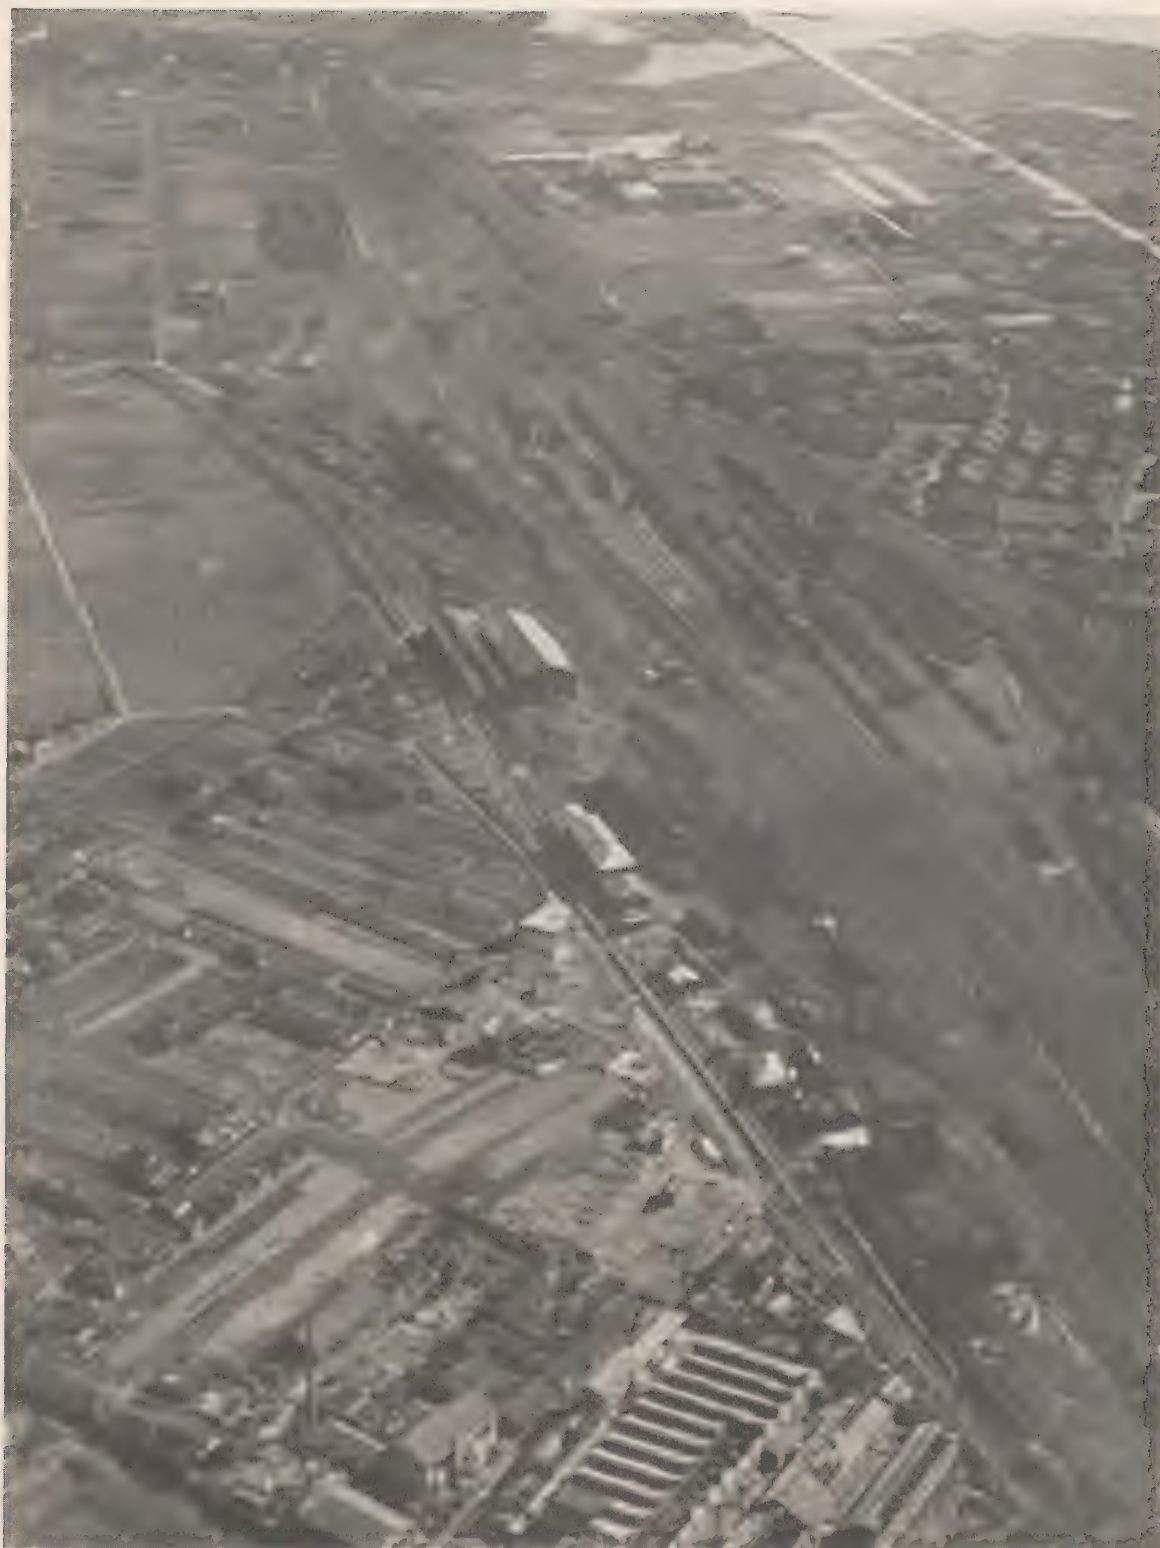
PHOTO 43-XIII. Classification area. Buildings damaged by blast, 9,600 feet from GZ.

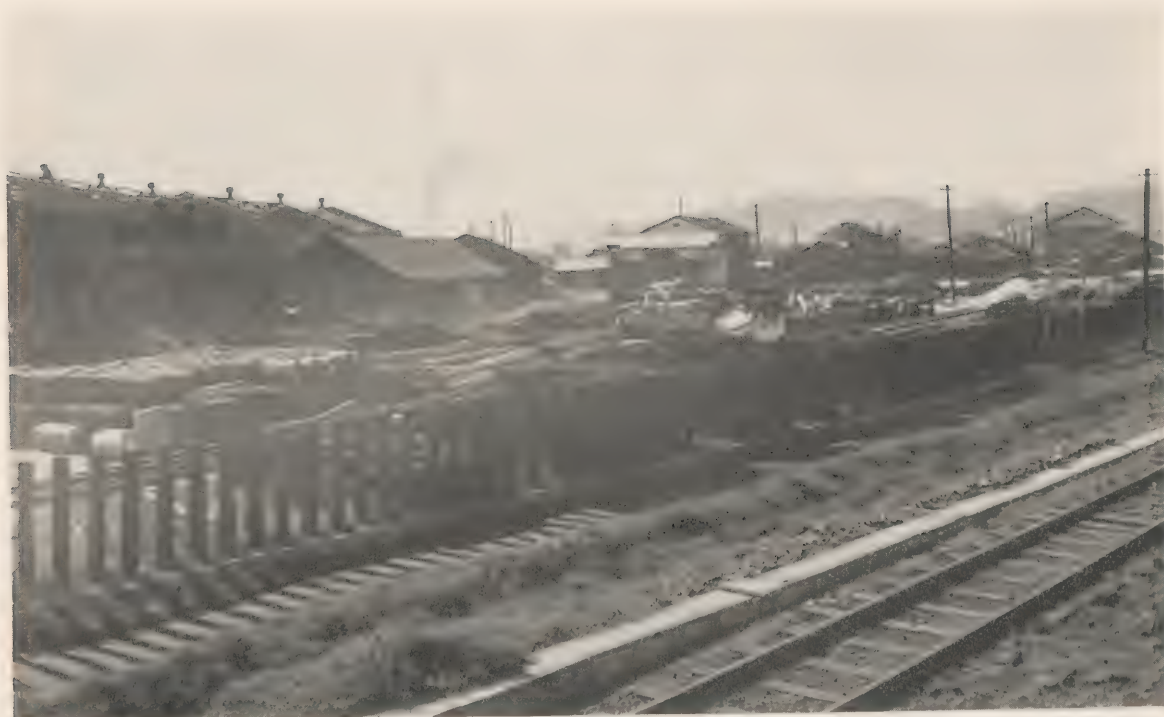
PHOTO 44-XIII. Warehouses damaged by blast, 9,200 feet from GZ.

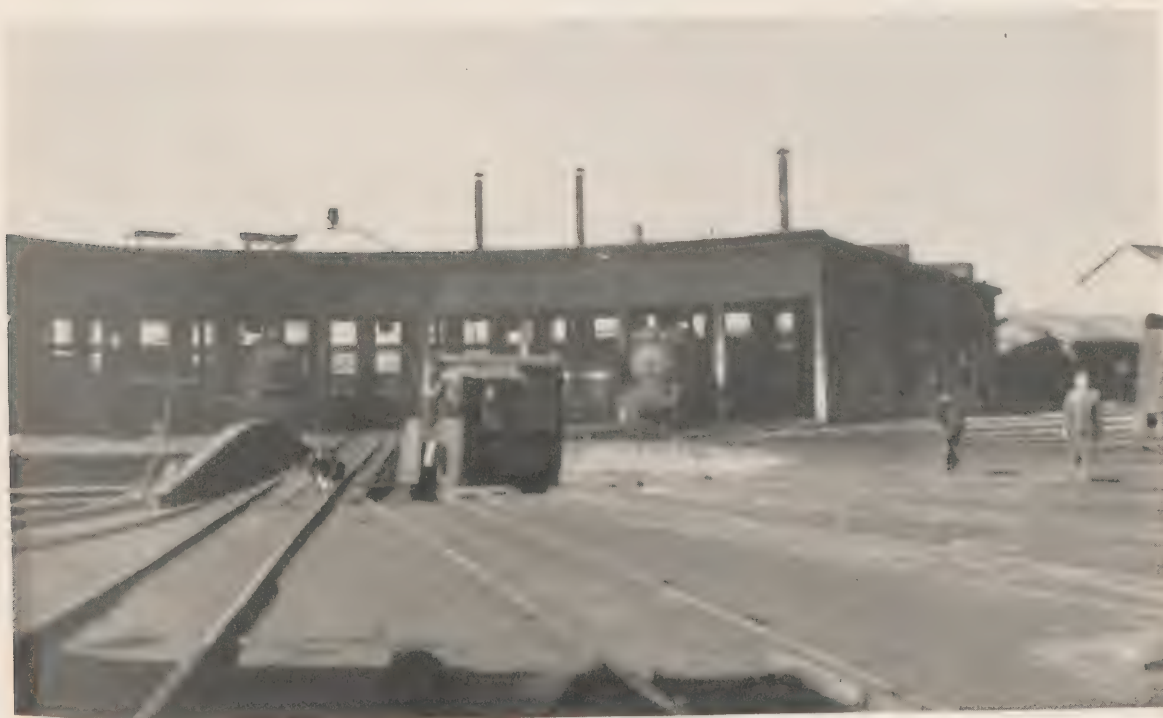
PHOTO 45-XIII. Roundhouse, showing minor blast damage, 8,700 feet from GZ.

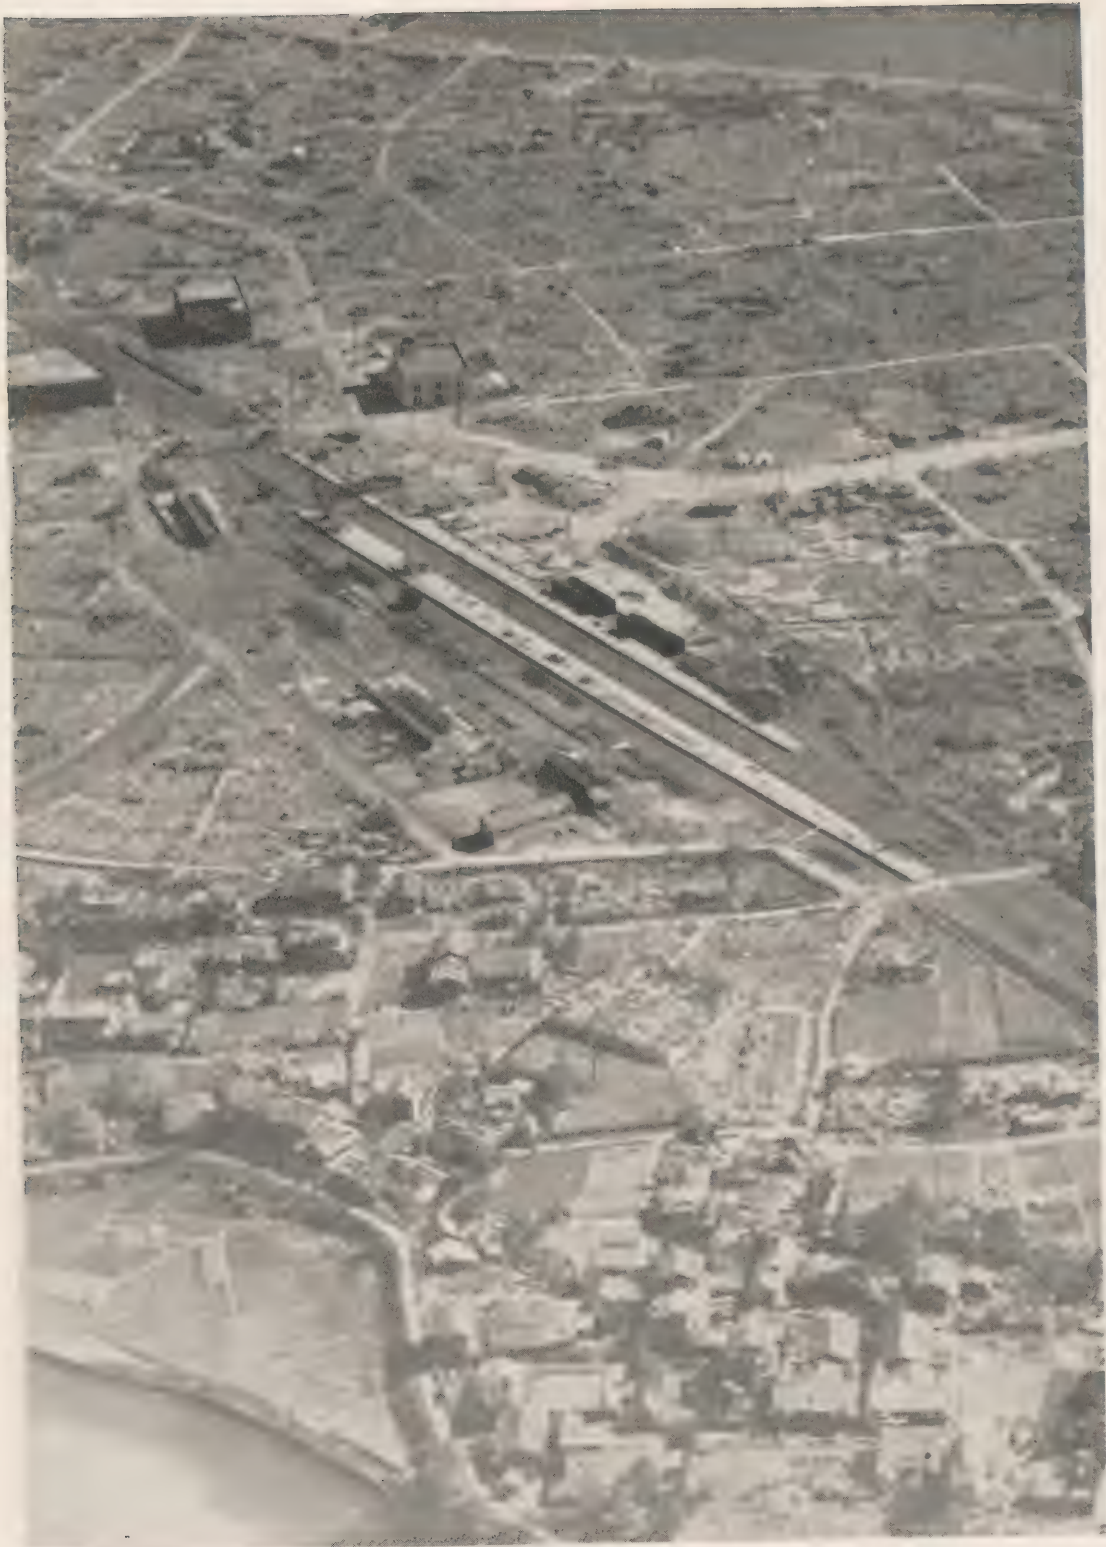
PHOTO 48-XIII. Yokogawa station area showing fire damage 6,000 feet from GZ.

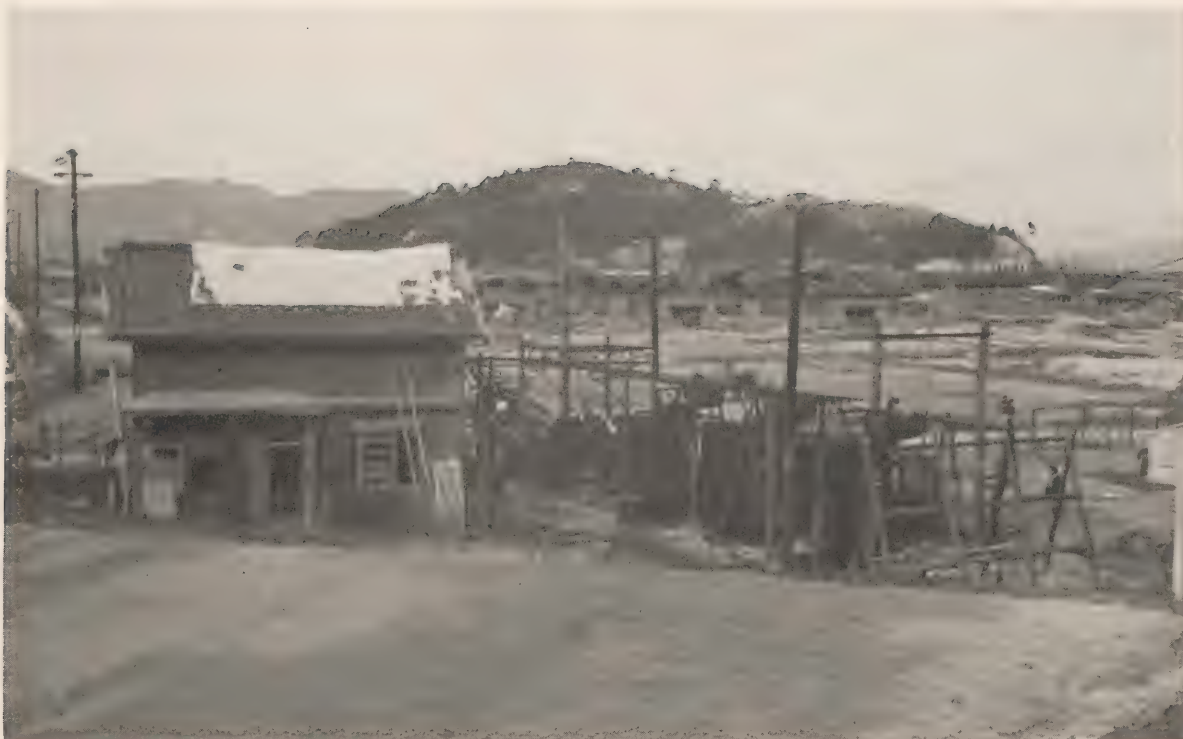
PHOTO 62-XIII. Eba substation. Building damaged by blast, 11,800 feet from GZ.

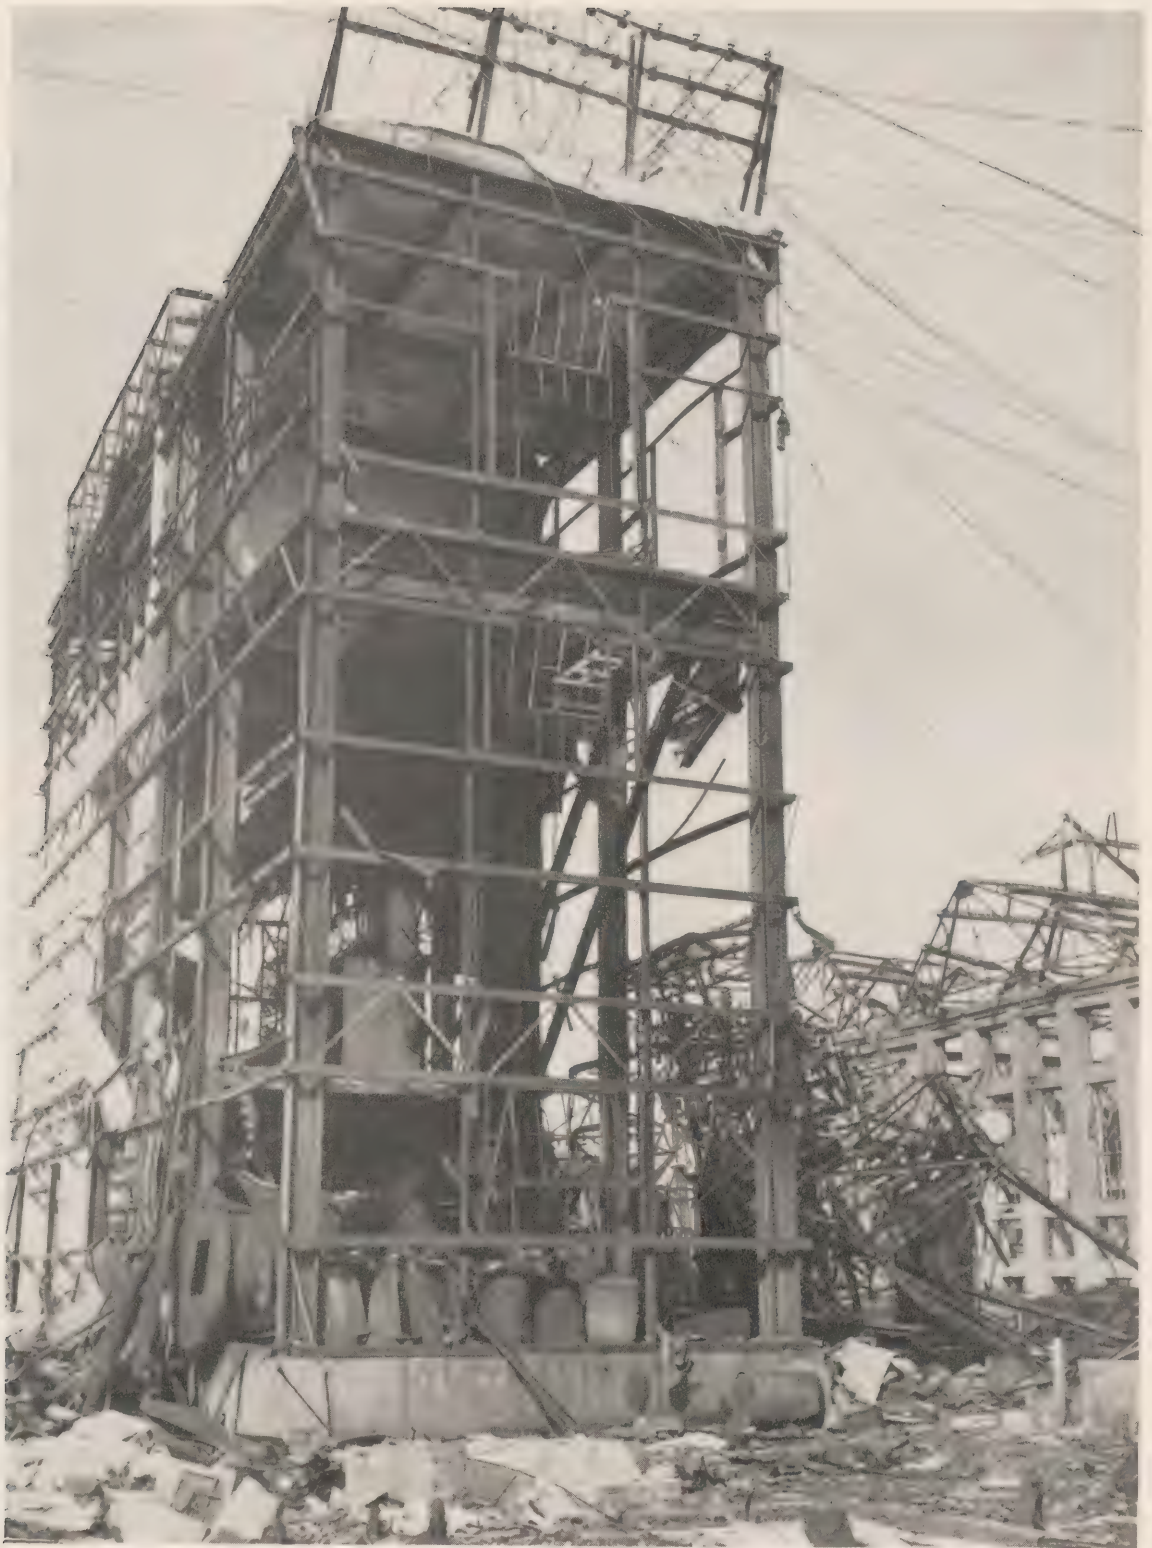
PHOTO 67-XIII. Blast and fire damage to Otemachi substation, 2,000 feet from GZ.

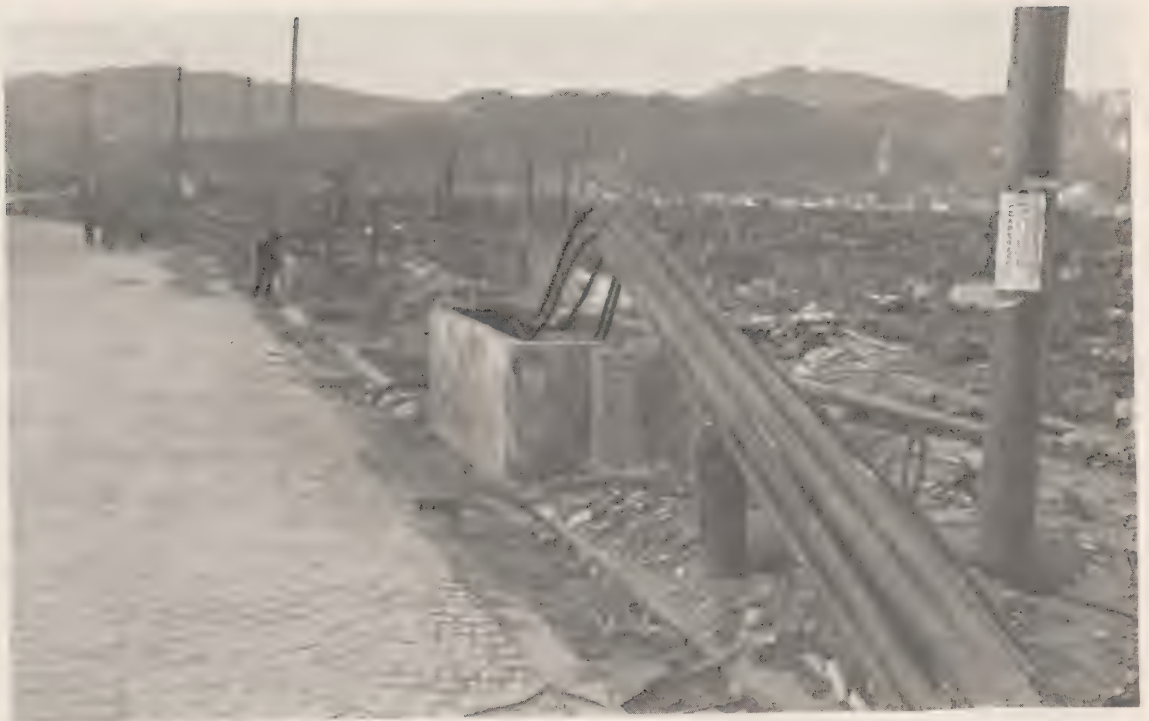
PHOTO 93-XIII. Telephone-cable transition from subsurface to overhead system damaged by blast and fire, 1,200 feet from GZ.

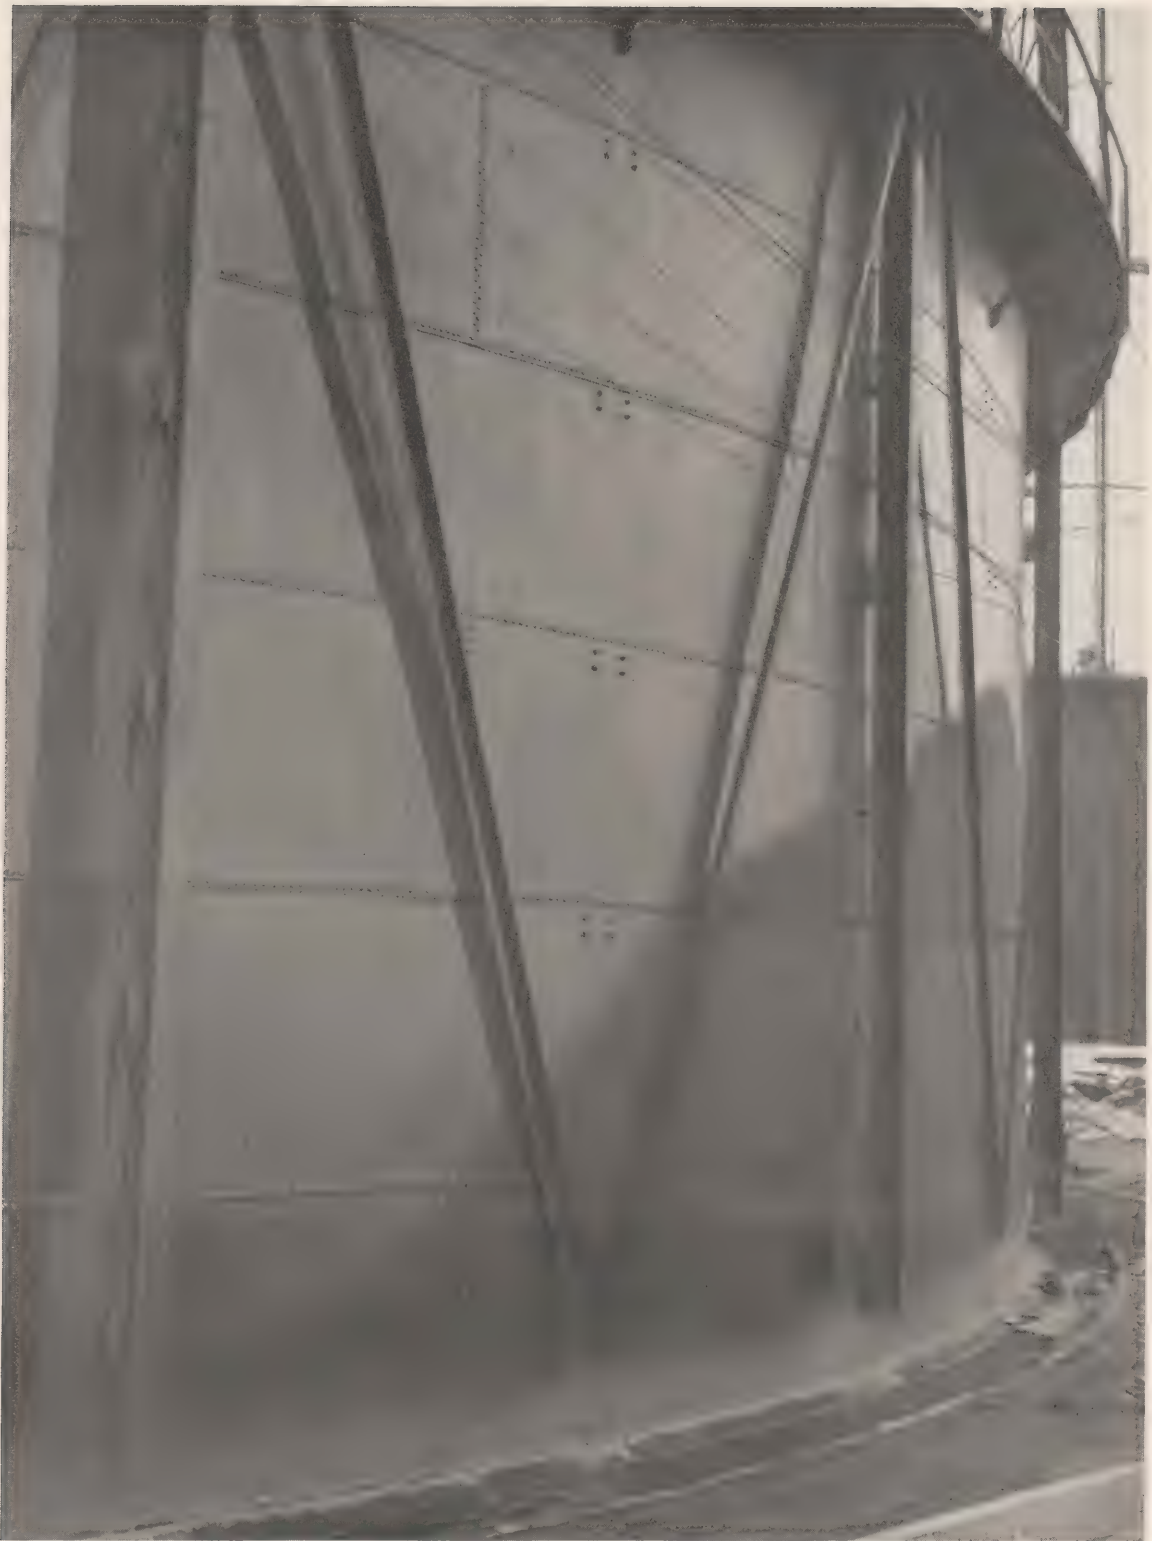
PHOTO 157-XIII. Flash burns on gas holder 6,500 feet from GZ. Note shadow of office building on holder.

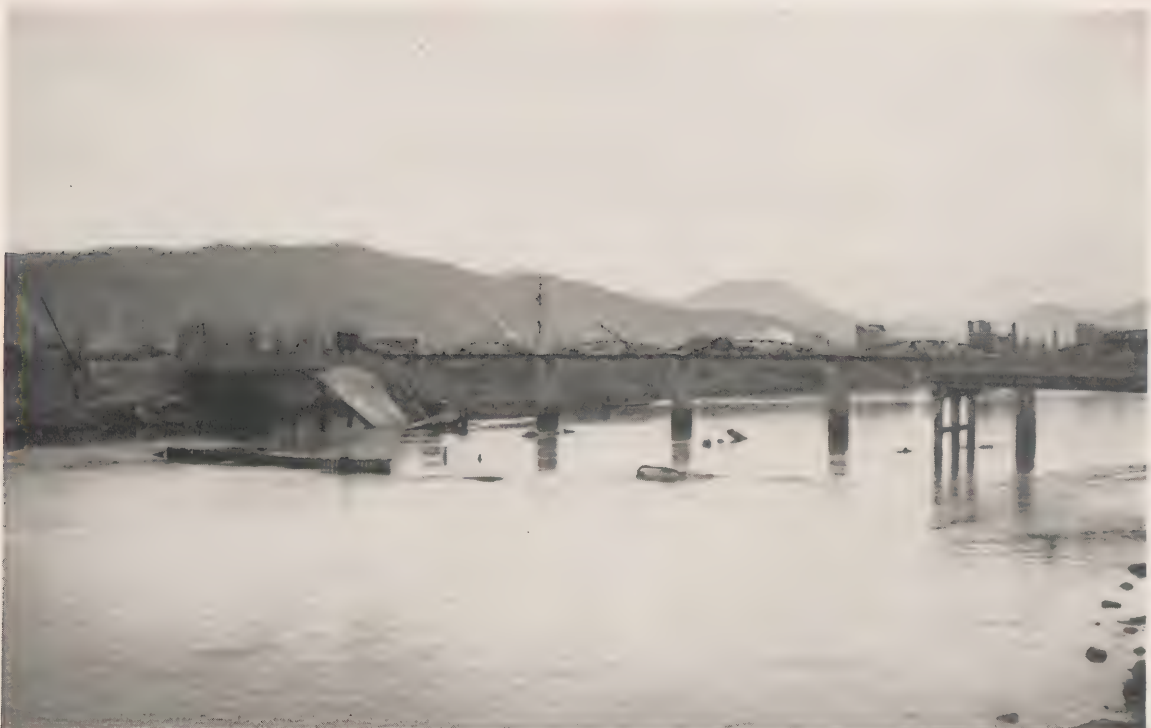
PHOTO 160-XIII. Bridge 30, carrying 6-inch, high-pressure and 12-inch, low-pressure gas mains, damaged by flood. Aqueduct 30A in background, 1,900 feet from GZ.

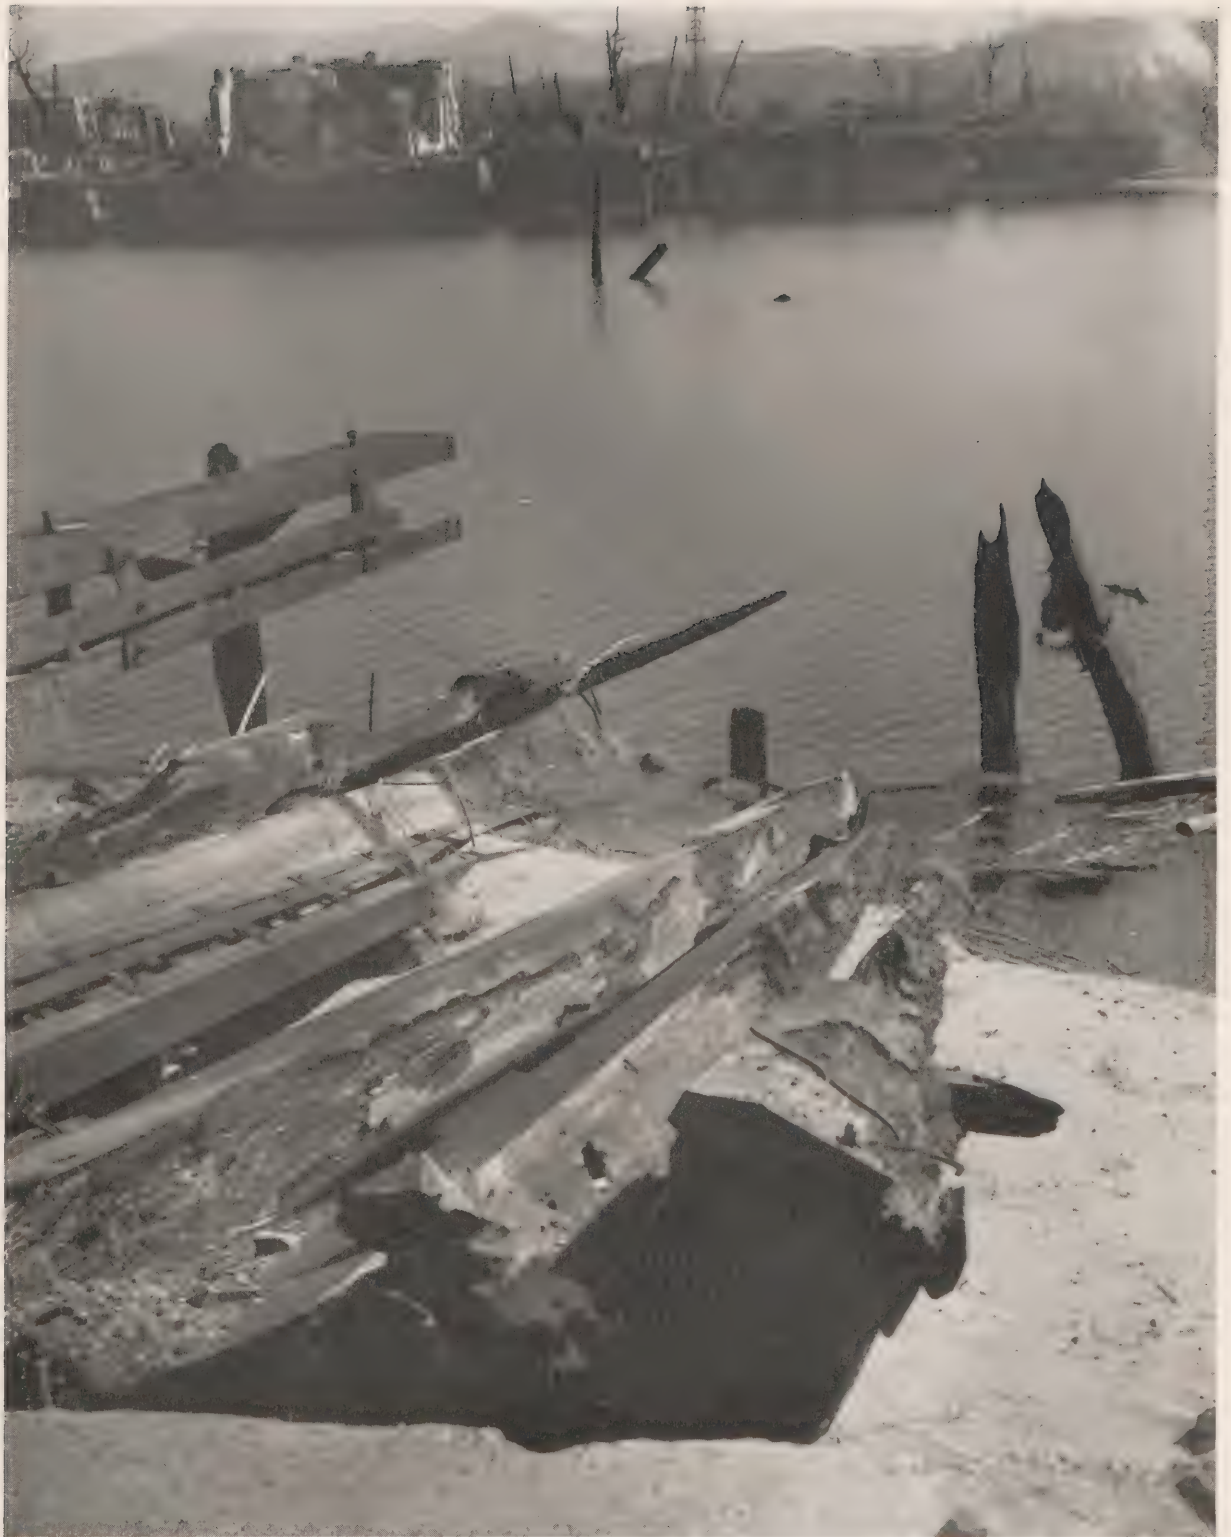
PHOTO 158-XIII. Damaged gas-main supports at Bridge 21A, 1,200 feet from GZ.

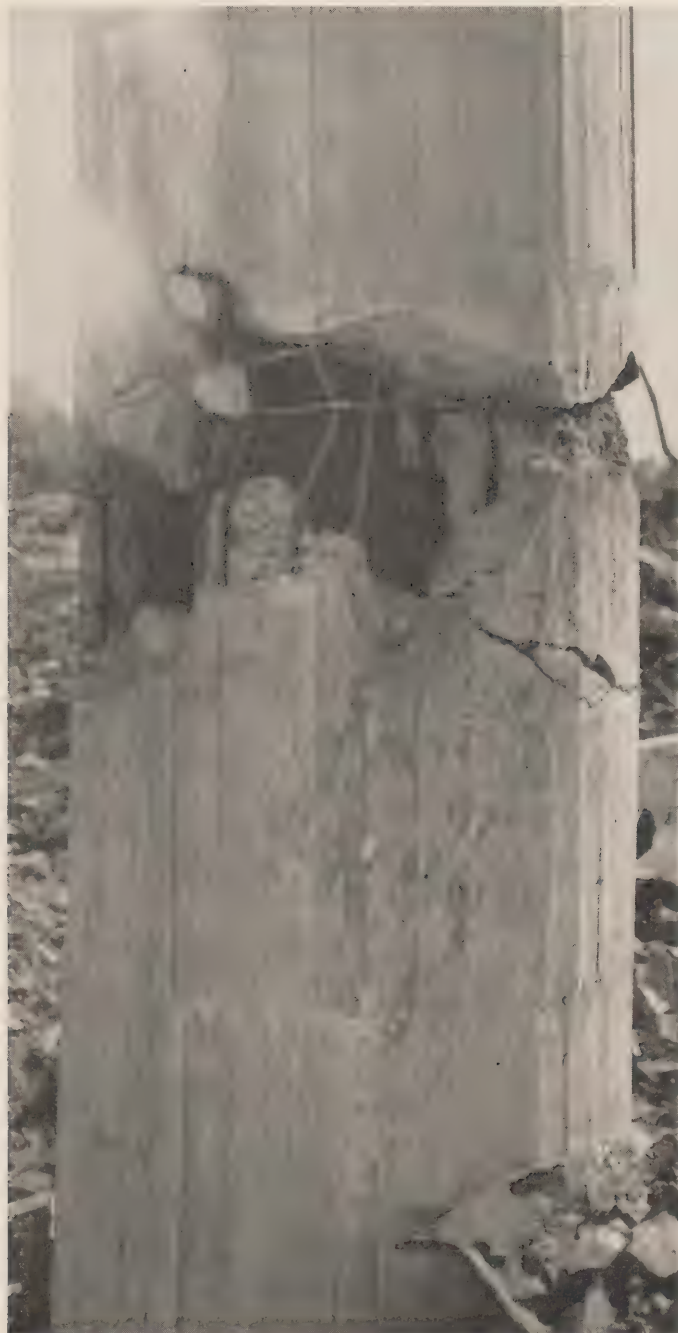
PHOTO 7-XIV. Stack 48. Fractured, reinforced-concrete stack, 1,300 feet from GZ.

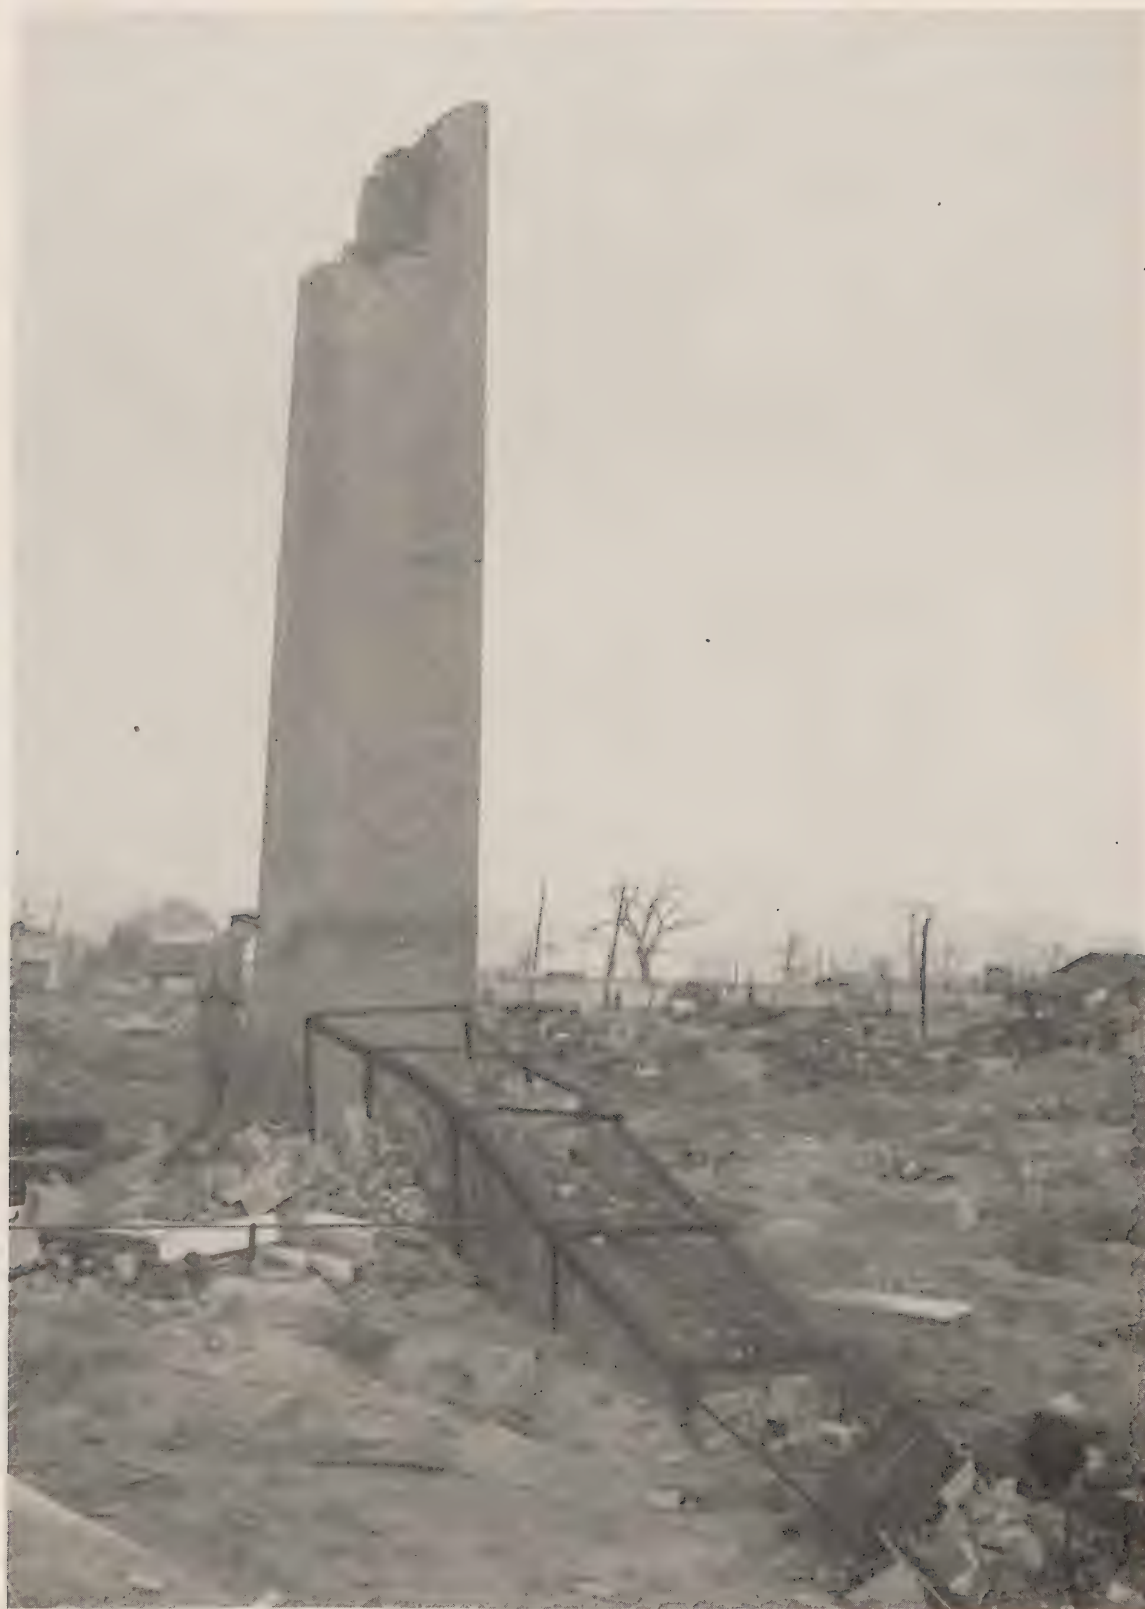
PHOTO 12-XIV. Stack 38. Square, brick, 4,500 feet from GZ. Sheared off at 30 feet. Note angle-iron bracing.
